# **TMS320C6457**

*Fixed-Point Digital Signal Processor*

**Silicon Revisions 1.0, 1.1, 1.2, 1.3, 1.4**

## **Silicon Errata**

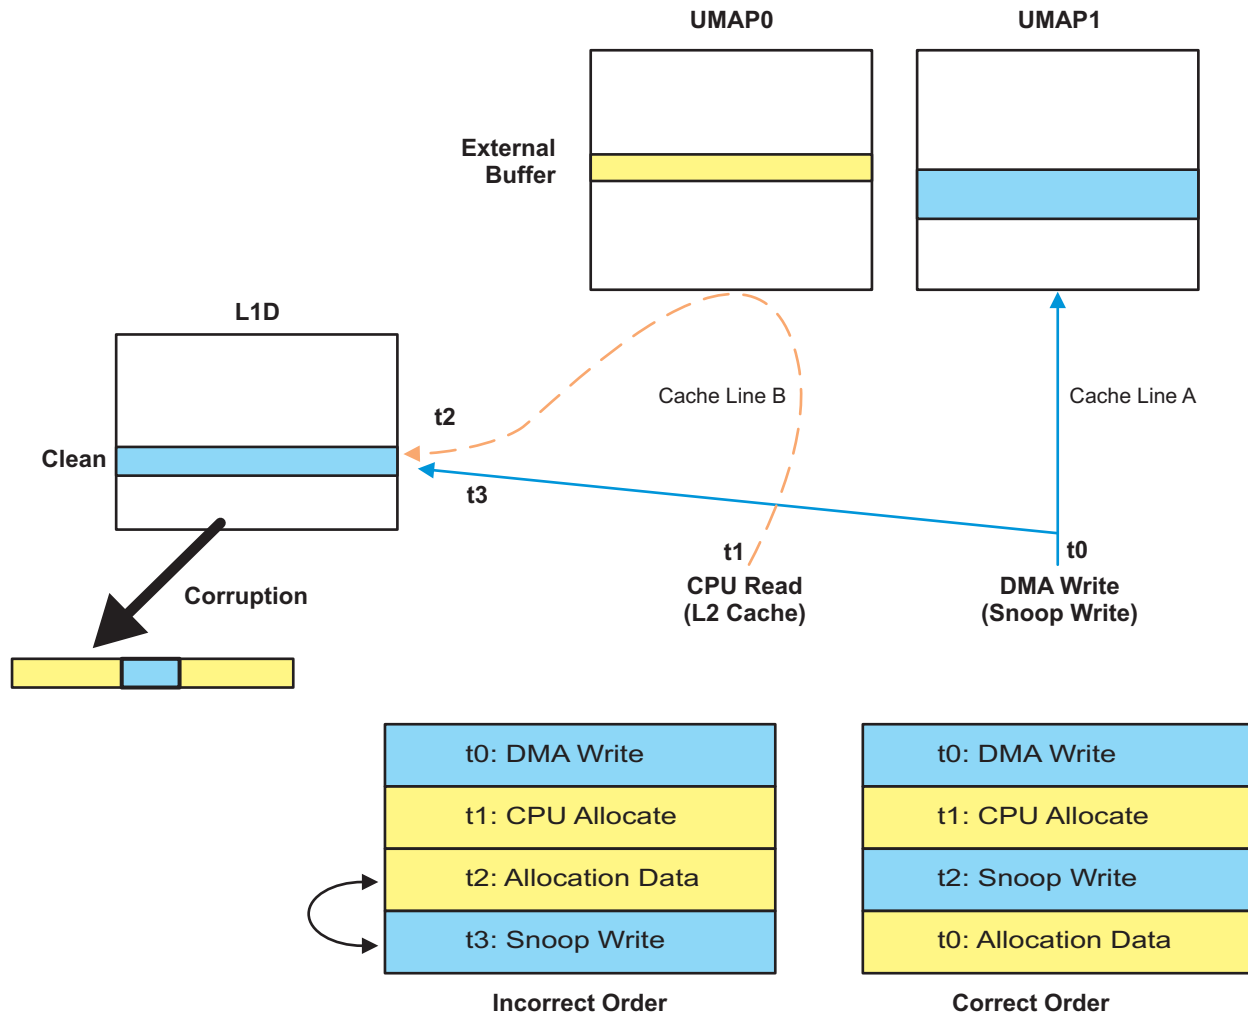
Figure 2 Cache Line Operations Flow

Figure 2 shows the flow of these operations, the incorrect order that causes the issue, and the correct order to avoid the issue. The solid line is Cache Line A and the dashed line is Cache Line B.

All of the conditions described above must be true to see the issue. The workarounds focus on picking one of the conditions and removing it so that the user does not need to worry about the other condition.

TI proposes starting with workaround 1 as an immediate fix. The other workarounds that follow may provide a solution with reduced overhead and/or simplified implementation depending on the system scenario.

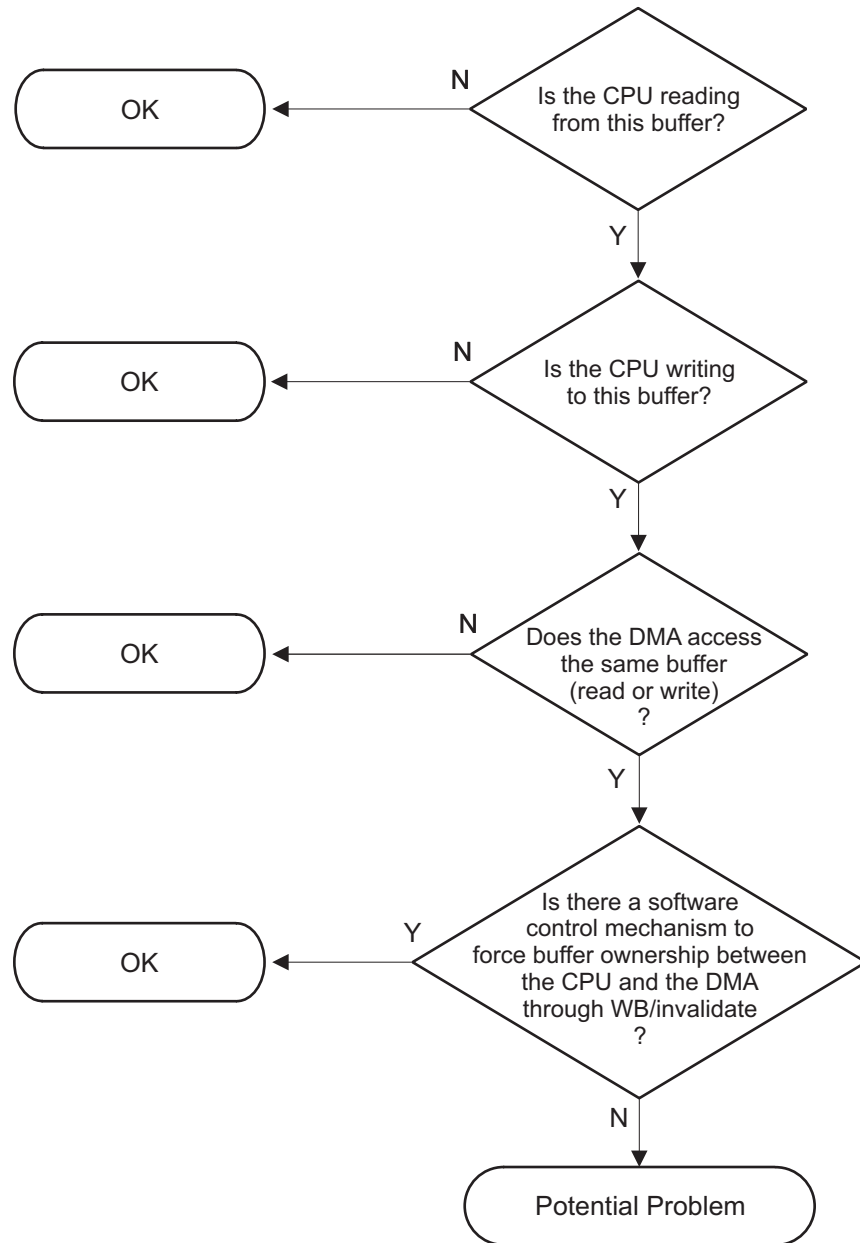
**Figure 4** Decision Tree

With all the steps above, it is fairly painful to determine if a particular buffer has the potential to see this issue. [Figure 4](#) is a simple decision tree to help make a determination for a particular buffer.

When using the above flowchart, if one of the *OK* fields is reached, then the buffer should not have a potential of being affected. When using the above flowchart, if one of the *Potential Problem* fields is reached, see the workarounds below.

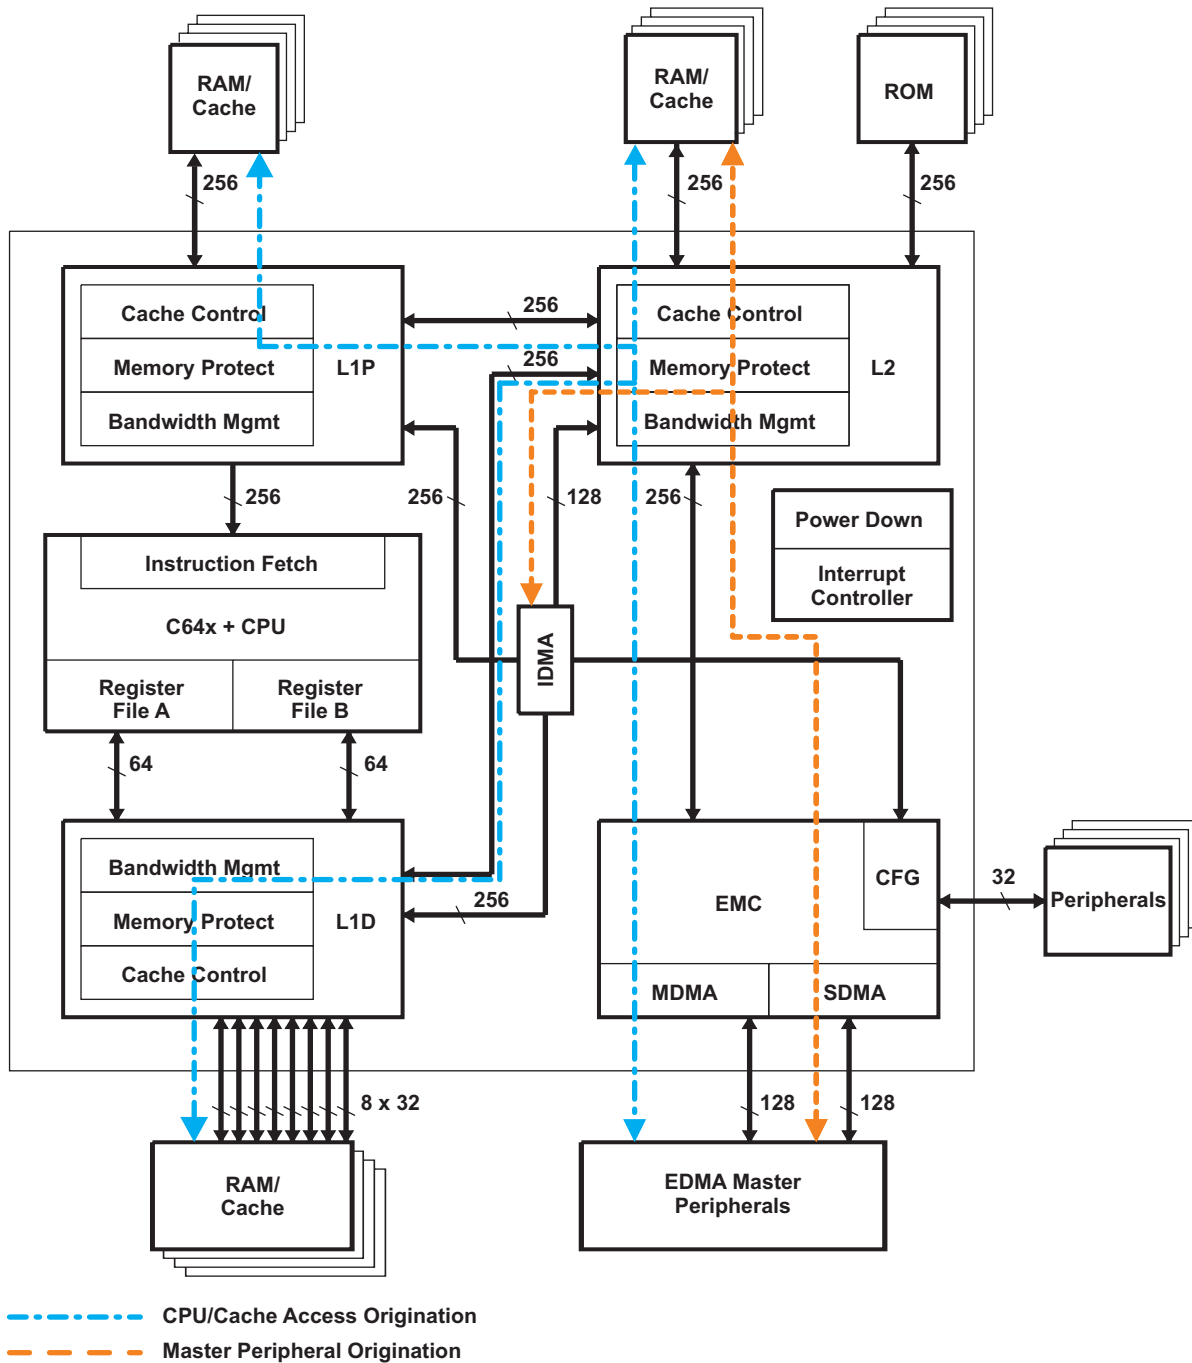
Figure 5 IDMA, SDMA, and MDMA Paths

Figure 5 is a simplified view for illustrative purposes only. The IDMA/SDMA path (orange lines) can also go to L1D/L1P memories and IDMA can go to the DSP CFG peripherals. MDMA transactions (blue lines) can also originate from L1P or L1D through the L2 controller or directly from the DSP.

The duration of the SDMA/IDMA stalls depend on the quantity/characteristics of the L1/L2 cache and the MDMA traffic in the system. Therefore, it is difficult to predict if stalling will occur and for how long.

SDMA/IDMA stalling and any system impact is most likely in systems with excessive context switching, L1/L2 cache miss/victim traffic, and heavily loaded EMIF.

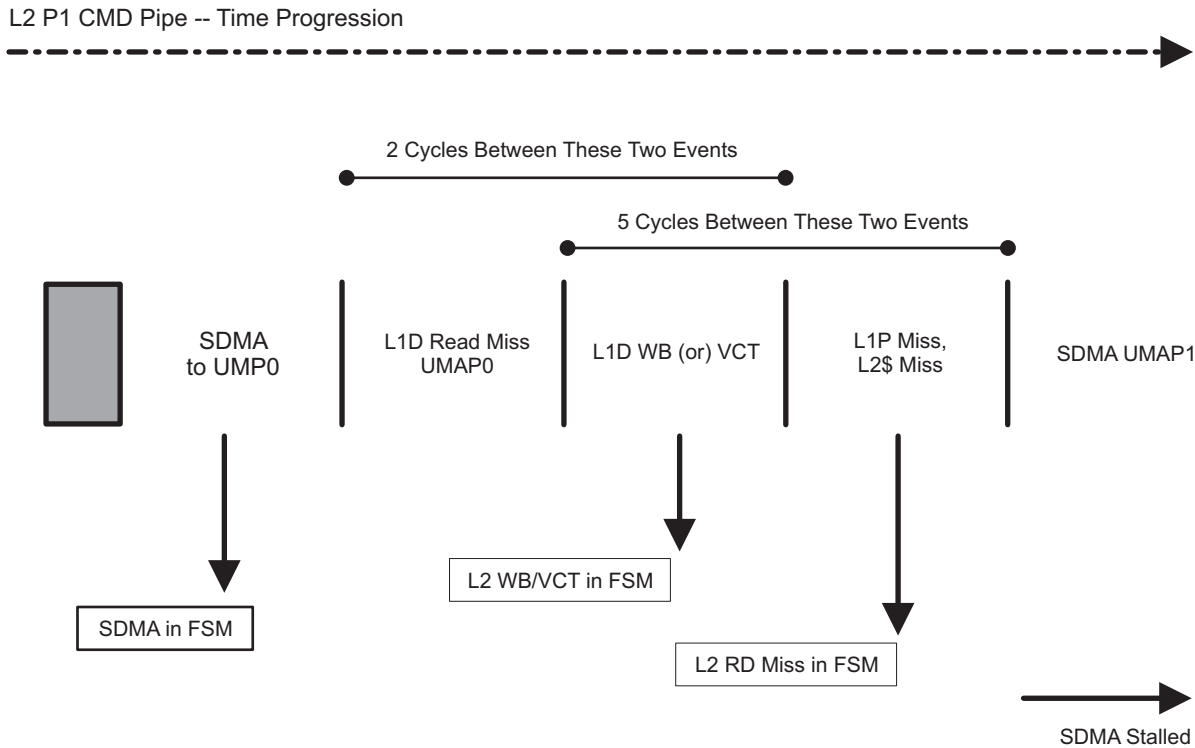
**Figure 6 L2 P1 CMD Pipe – Time Progression**

The SDMA in item 1 sets up a bank conflict for the L1D\$ read in item 2. The L1D\$ allocate in item 2 prevents the L1D\$ write/victim (3) from advancing, so it is stuck in the pipeline. This occurs at the same time as an L1P\$ allocate that also results in an L2 access to external memory (4), which is also in the same pipeline stage as the L1D\$ write/victim (3). At this point, the L1P\$ allocate (4) advances to the next pipeline stage but the L1D\$ write/victim (3) is still stuck waiting on the L1D\$ allocate (2). This now sets up the pipeline for the stall condition, which is actually triggered by an SDMA to UMAP1 (5). This is what causes further SDMAs to stall. After the L1P\$ allocate (4) is complete, (2) resolves, allowing (3) to resolve thus freeing the SDMA pipeline again. Therefore, the stall is effectively for the length of the L1P\$ allocate in item (4).

Please note that the above four conditions do not guarantee that a stall will occur, it may stall depending on the timing between the transactions. Steps 2 and 3 must occur within two CPU cycles of each other and steps 3 and 4 must occur within five CPU cycles of each other.

Figure 6 shows this timing relationship.

**Workaround 1:** Leave in previous SDMA/IDMA stall workarounds (for devices with the original SDMA/IDMA stall).
